Report on Final Remedial Action
at the Wade Site
Chester, PA

REPORT ON IMPLEMENTATION OF
FINAL REMEDIAL ACTIONS AT THE
WADE SITE IN CHESTER, PENNSYLVANIA

Pennsylvania Department of Environmental Resources

Roy F. Weston, Inc.
West Chester, Pennsylvania

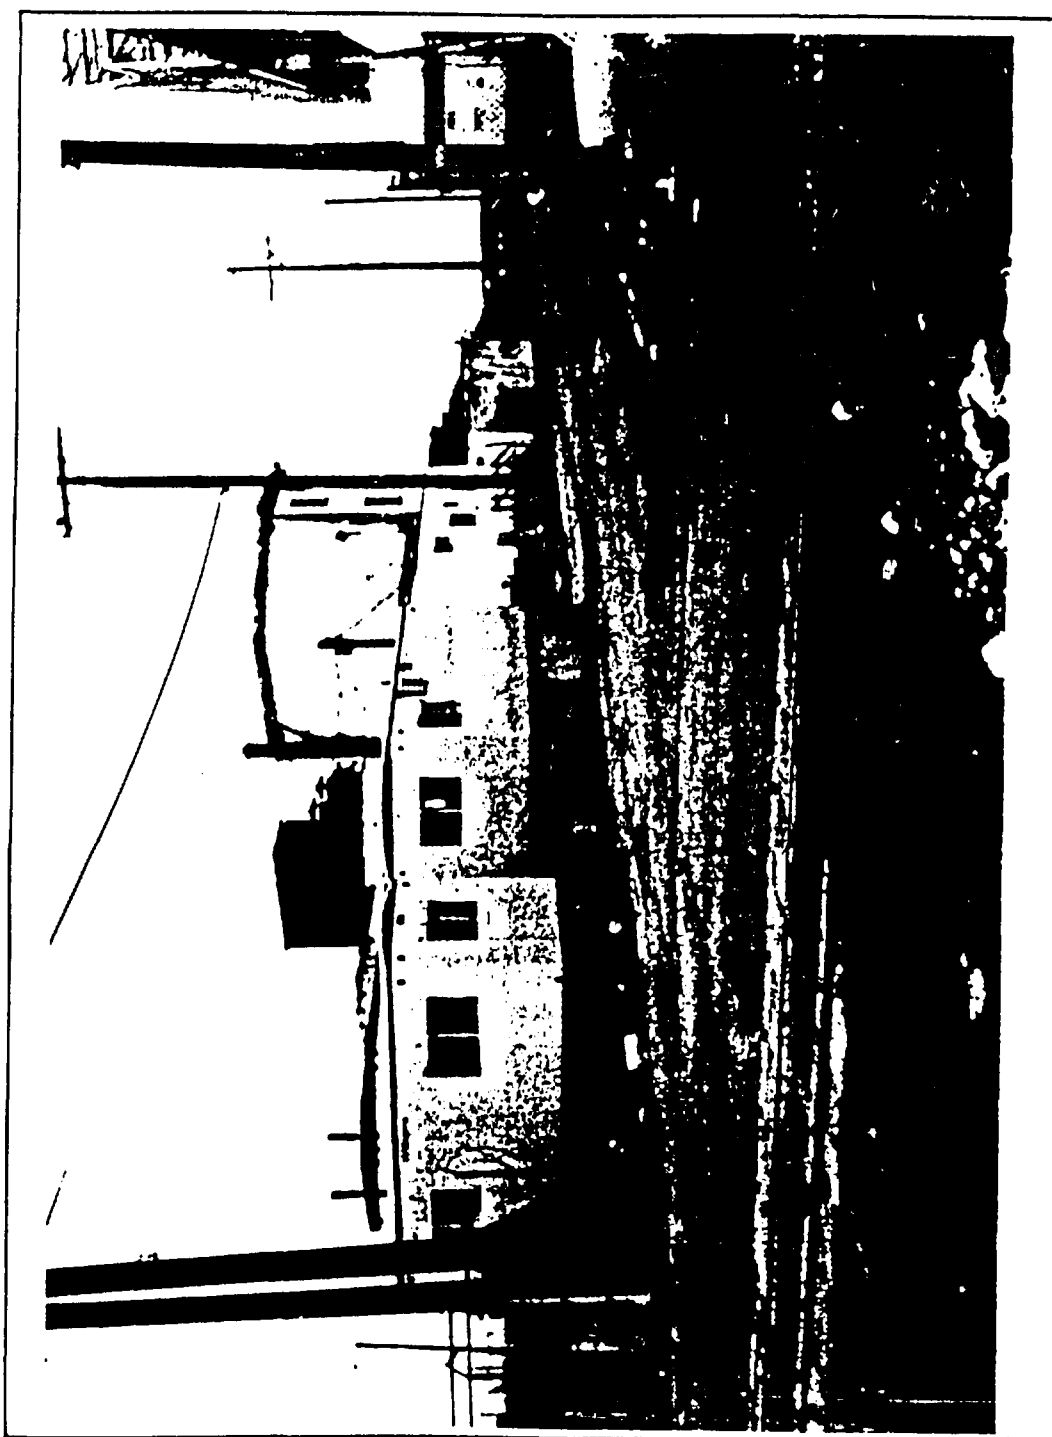
FIGURE 2-3 ON-SITE FACILITIES

RES initiated mobilization on January 8, 1987 with the delivery of two office trailers, a guard house, a personnel locker trailer, and an equipment trailer. The office trailers were blocked up and levelled for use during the pre-construction meeting held on-site on January 9, 1987. Installation of the required utilities, including electric, telephone, water, and sewer services, was completed in accordance with the requirements of the RFQ/P. Due to the impending winter weather, all water lines were traced with heat tape and insulated to prevent freezing.

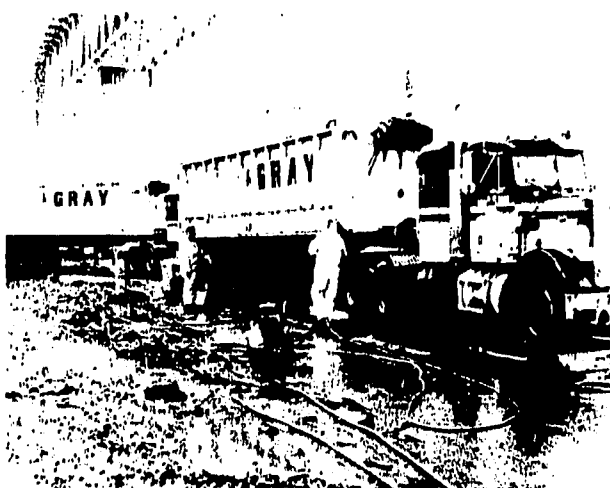
1. Dump Trailer Undergoing Decontamination
On Steel Containment Pad.

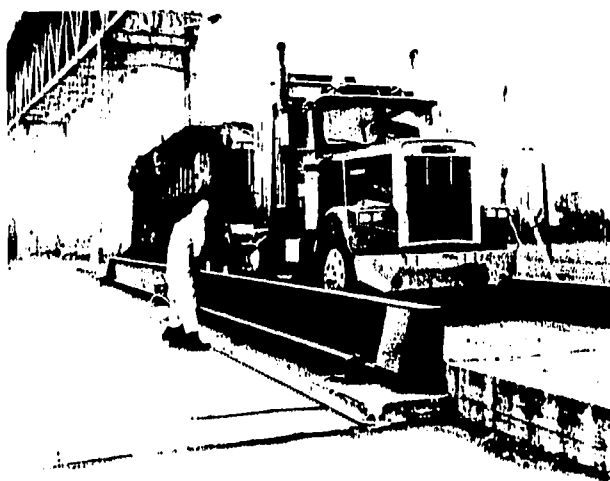
trailers for transport to the GSX landfill in Pinewood, South Carolina. Tare and loaded weights of the dump trailers were obtained and recorded using the on-site, state certified scale (Figure 2-7). The trailers were lined with plastic sheeting prior to loading. Prior to departing the site, the loads were covered with tarpaulin to prevent loss of the soil during transport and the required documents including weight records, bills of lading, and hazardous waste manifests were completed and provided to the transporter. It should be noted that RES prepared the manifests for signature by the DER.

2. Transport Vehicle Being Weighed Prior
To Departure.

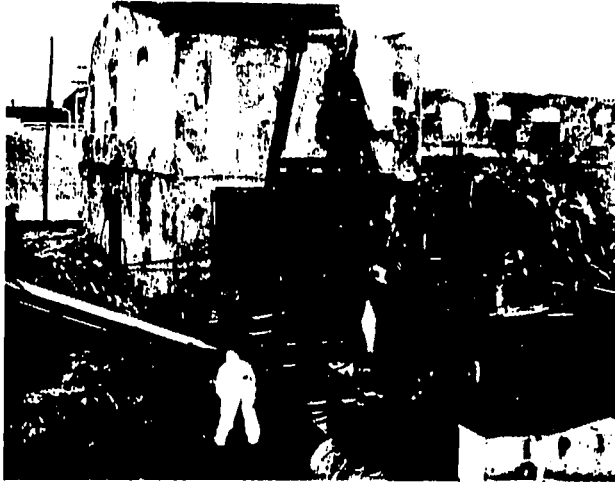
1. Transportable Tire Shredder

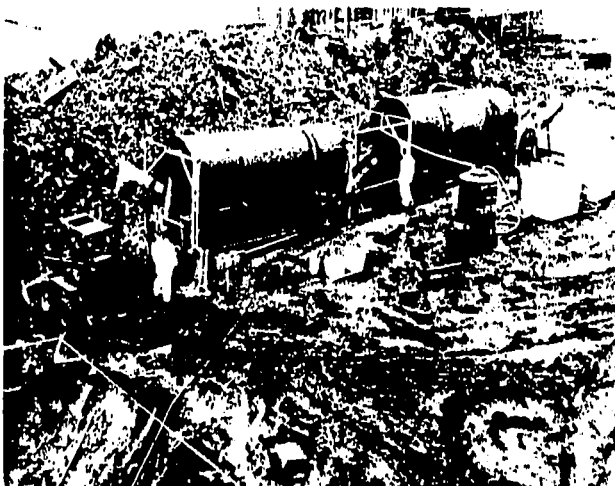
2. Shredded Rubber Decontaminating Processor

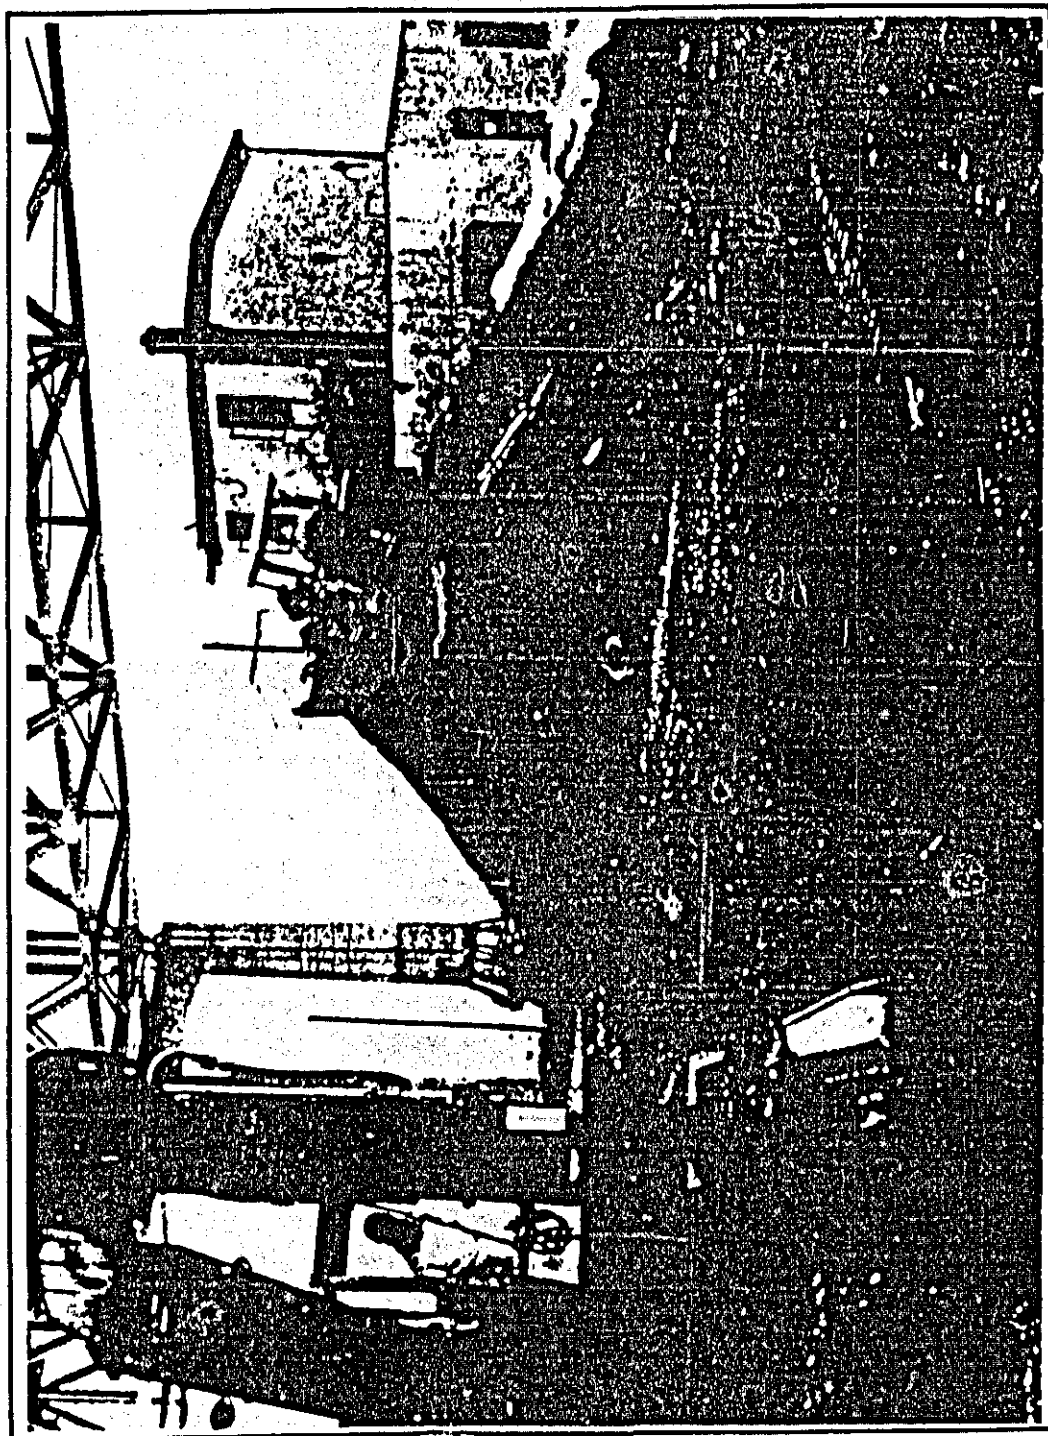
FIGURE 2-11 EXCAVATED SOIL STOCKPILE

RES initiated excavation of soils according to the Soil Removal Plan (Drawing 102 of the RFQ/P) within the grids located near the front fenceline. The soils were stockpiled near the former office building (Figure 2-11) prior to loading, transport, and disposal according to the procedures described in Section 2.3.3 for the surface piles. Excavation of the soils along the front fenceline resulted in a noticeable aromatic odor; however, this was of very short duration and was observed only in the immediate vicinity of the site (within approximately 25 feet). Perimeter air samples on the front fence revealed that air quality in the area was well below the action limits set for the site.

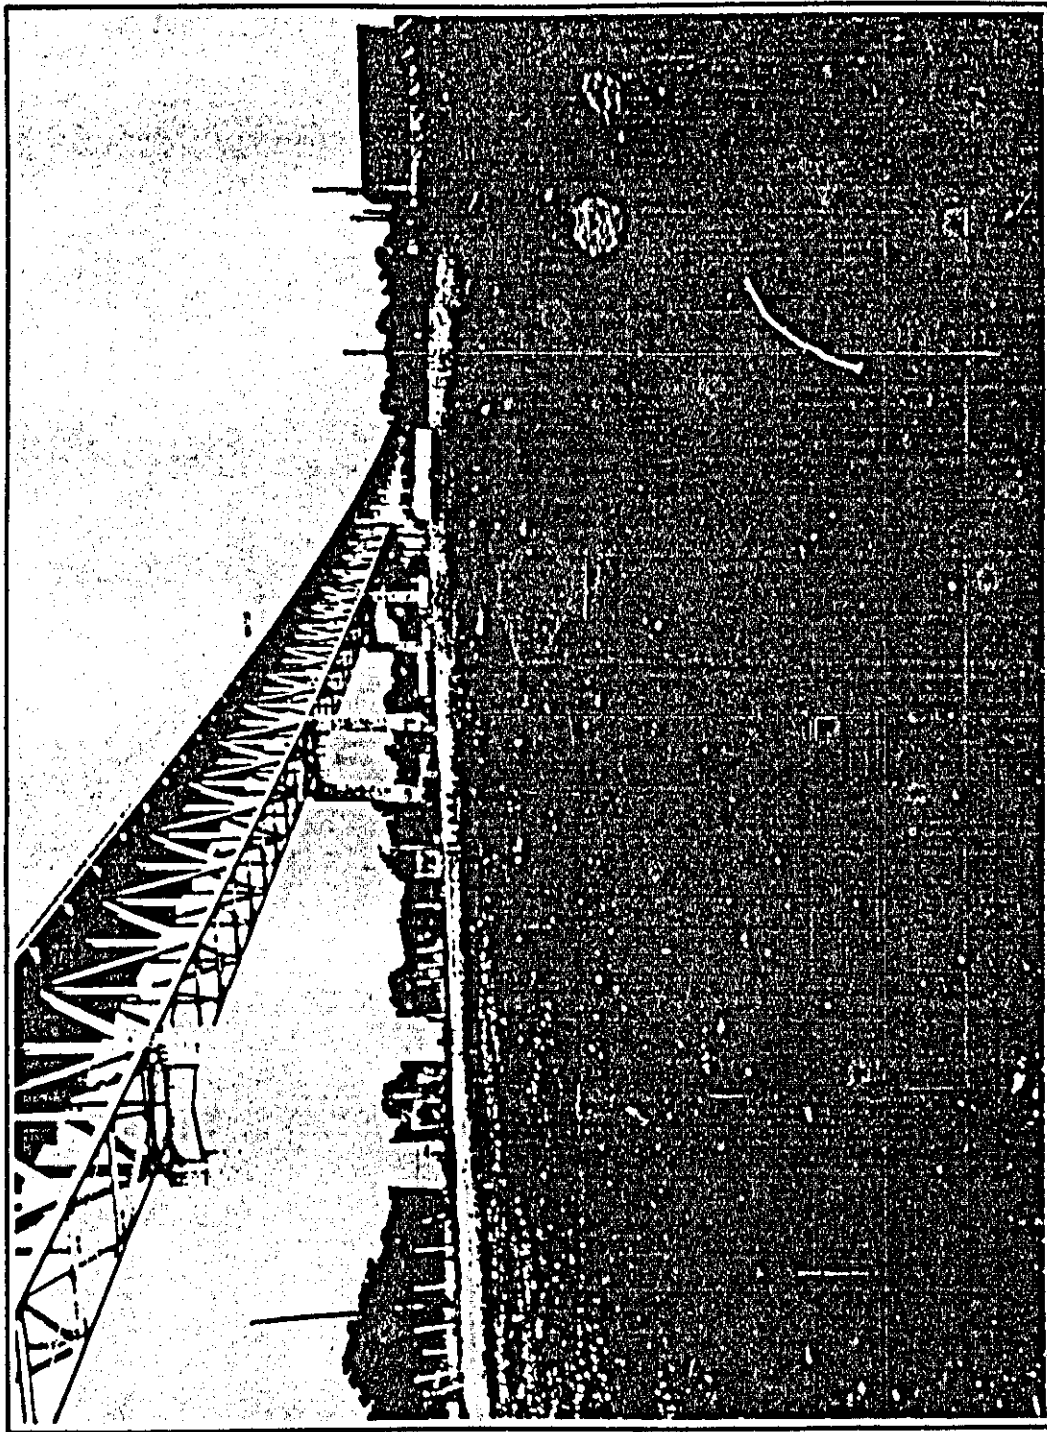
FIGURE 4-1 DRAINAGE SWALE ALONG PECO FENCELINE

At the request of the Site Representative, on March 12, 1987 a WESTON civil engineer visited the site to evaluate the location of the drainage swale along the western flank of the site. The principal recommendation resulting from this visit was that the swale should be relocated to the northeast and out of the roadbed. Certain recommendations regarding curbing modifications south of the axial crest in the road were also developed (see WESTON memo of March 16, 1987; Appendix N). Revisions were made to the RFQ/P Drawing Numbers 104, 105, and 106 to reflect these changes. Copies of the revised drawings were transmitted to the RES' Site Supervisor by the Site Representative in a letter dated April 24, 1987 (Appendix N).

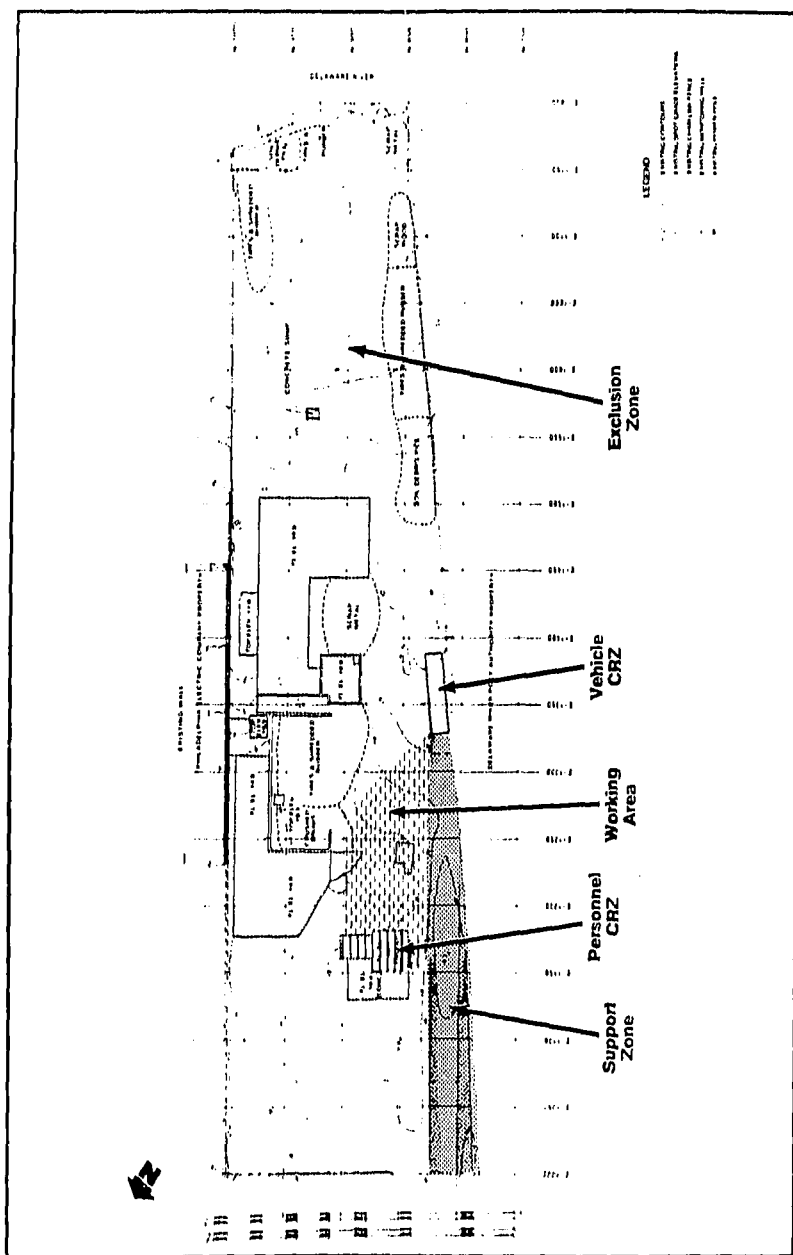
FIGURE 5-1 WORK ZONES

The third work zone established by RES was the exclusion zone (EZ). The EZ consisted of all of the remaining land area inside the fenced portion of the site. Throughout the majority of the site work, employees entering the EZ were required to utilize protective equipment, including air purifying or supplied air respirators. Access to the EZ was only to be gained via the CRZ and all individuals exiting the EZ were required to pass through the CRZ prior to entering the support zone.

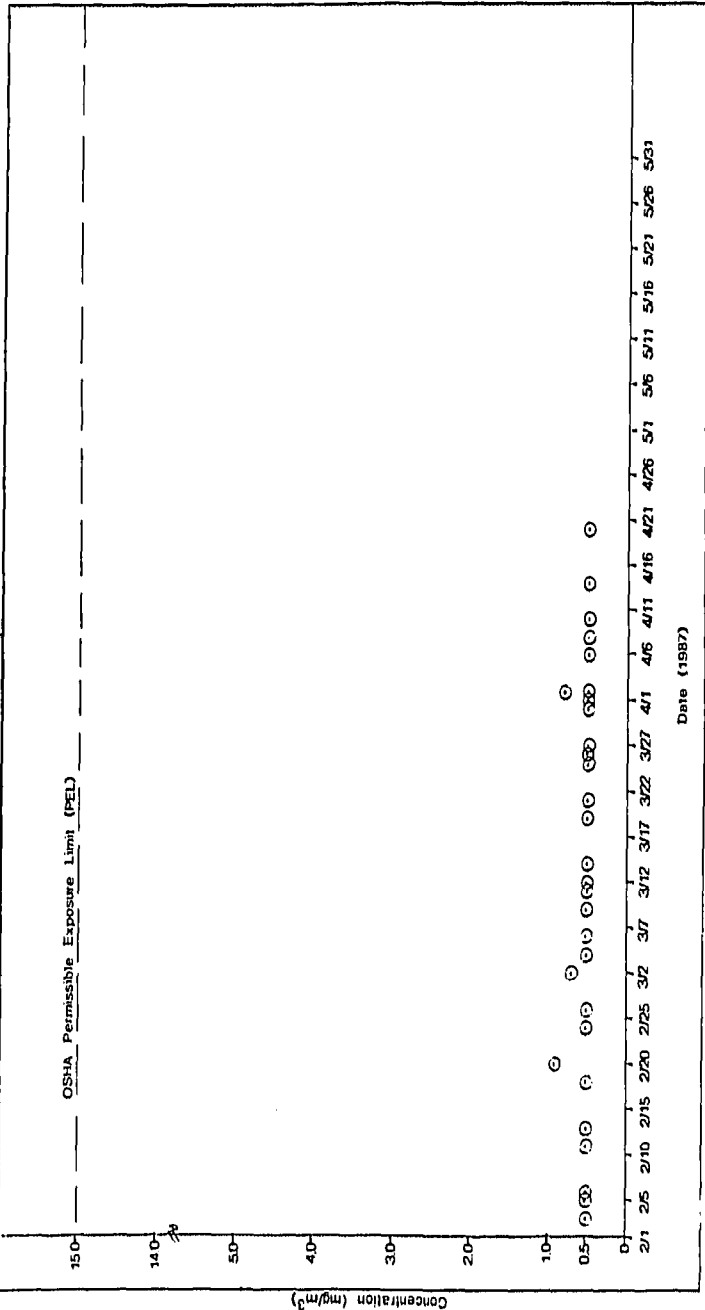
9-7-88 DATE 2-28 DATE	FIGURE 5-3		SHEET 1 OF 1 PAGE
	SUBJECT PARTICULATE DATA FOR WADE SITE PERIMETER MONITORING - UPWIND

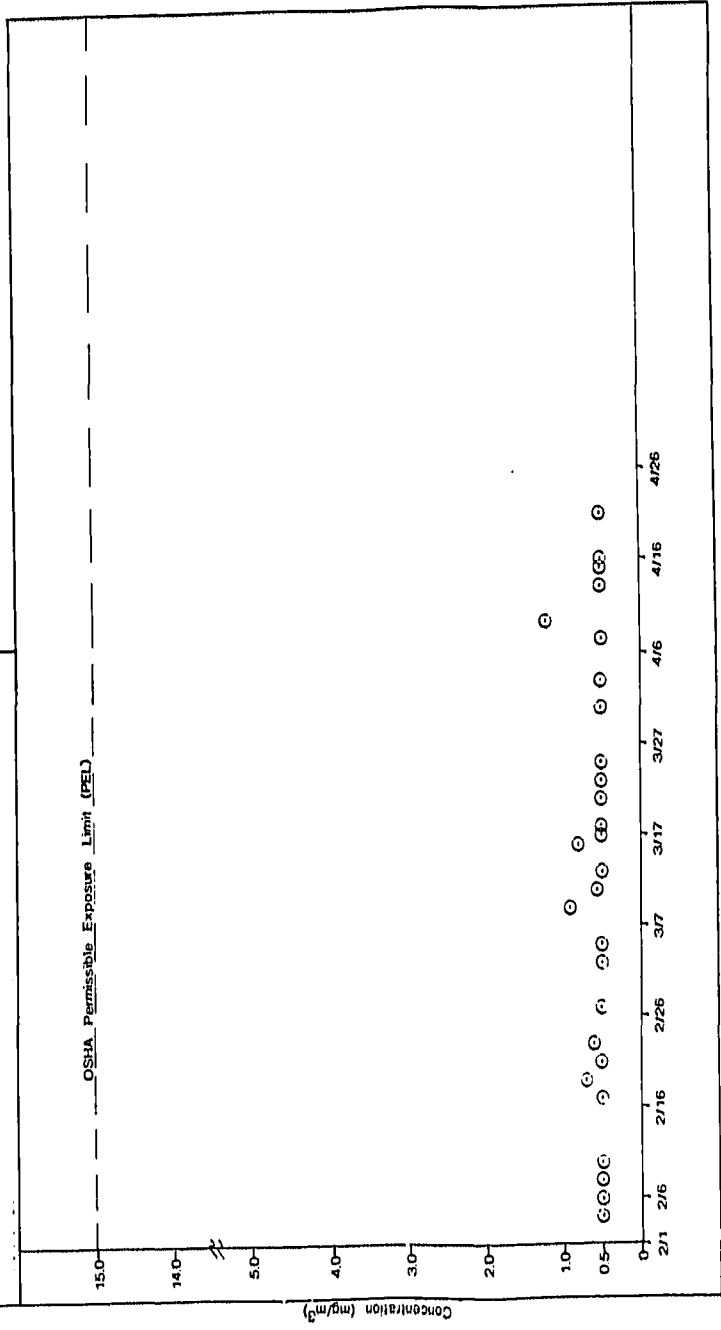
72C 2 28 2311		3412 DI	
FIGURE 5-4			
PARTICULATE DATA FOR WADE SITE PERMETER MONITORING - DOWNWIND SAMPLES			
503217		JOB NO 07392603

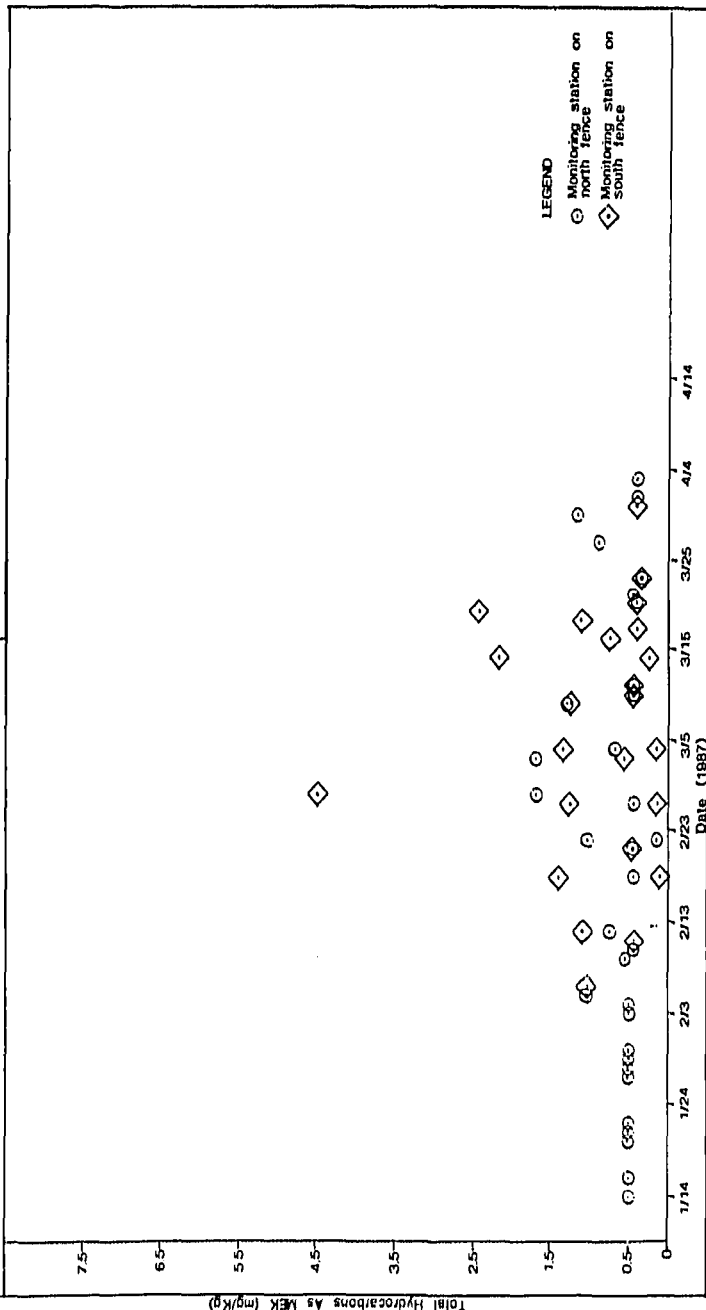
The real time air monitoring showed that little or no volatile organic emissions resulted from implementation of the remedial action. The only exception to this occurred during excavation in grids 1, 17, 33, and 49 along the fenceline bordering Delaware Avenue. A sweet aromatic odor was noted in the support zone during this work and the health and safety technician was asked to investigate using the HNu monitor. It was found that the odor apparently originated from grid 33 and, although a slight odor was noticeable immediately outside the fence, it was not measurable using the HNu past the site fence.

BY JEC	DATE 2-88	FIGURE 5-5	SMITH ID	1 PAGE
FOR B.	DATE	TOTAL HYDROCARBON DATA FOR	JOB NO. 07392603	
SUBJECT: WADE SITE PERIMETER MONITORING STATIONS
